СЕЙСМОСТОЙКОСТЬ СООРУЖЕНИЙ SEISMIC RESISTANCE

RESEARCH ARTICLE / НАУЧНАЯ СТАТЬЯ

Seismic response of stone masonry building with wooden band

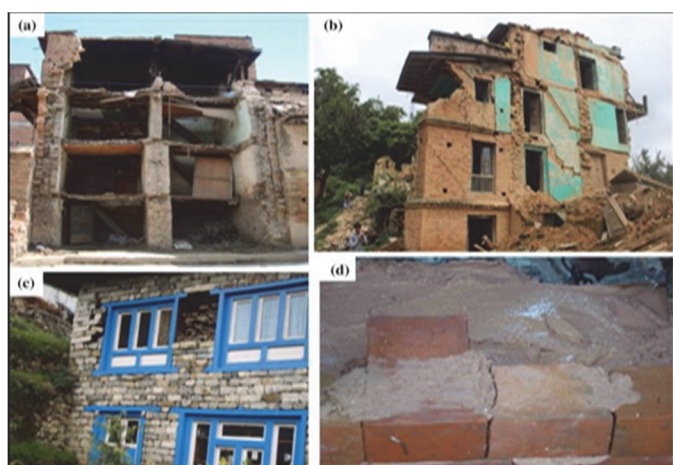
Figure 1. Failure mode of masonry houses:

a – out of plane collapses of load bearing masonry wall in Bhaktapur;
b – heavily damaged masonry structure in Chautara due to out of plane collapse of majority of walls; *c* – delaminating of the masonry observed in stone masonry wall in Solukhumbu (Everest base camp area); *d* – common practice of mortar placement for masonry construction [12]

In view of structural performance masonry structures have limited resisting capacity against earthquake (Figures 1 and 2) [7]. So, it is vital to have a study to address the present status of the structural capacity of the traditional house whether they are capable of withstanding the possible future seismic impact. The responsibility of a structural engineer is not only limited to construction of modern structures, but also to preserve the traditional structures which reflect the state of civilization, tradition and culture [8; 9]. In this regard, the present study becomes an essential step in the strengthening of traditional house for our future generations and the study of the Sinja Valley (Nepal) housing trend [10; 11]. Likewise the analysis is done enhancing seismic impact worldwide.

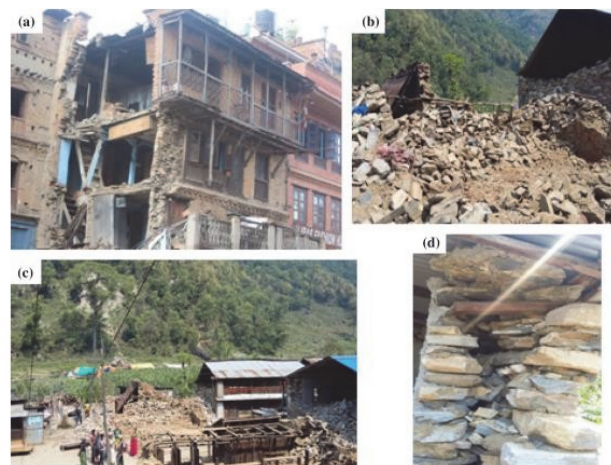
Figure 2. Failure mode of masonry houses:

a – pounding and progressive failure on the building situated on edge;
b – complete collapse of row houses in Baluwa (near epicenter);
c – progressive failure on row houses and good performance of timber frames;
d – stone masonry failure

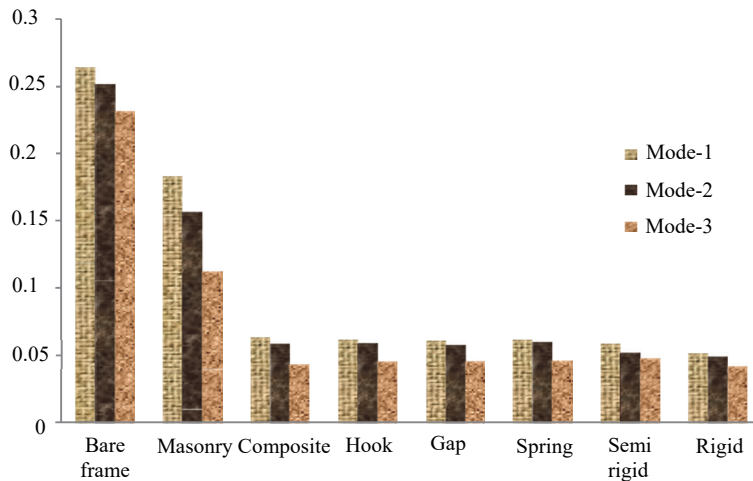
Figure 6. Comparison of period

Fundamental time period of different models

Fundamental time period of hook, masonry, bare frame, composite, gap, spring and rigid models obtained as 0.0613, 0.183, 0.264, 0.063, 0.0603, 0.061 and 0.051second respectively (Figure 6). Maximum fundamental time period obtained is in care of bare frame and minimum in care of rigid. There is no significance difference in time period among hook, composite, gap and spring. It can be seen that influence of timber band is significant to increase global lateral stiffness of the building that caused de-

crease in fundamental time period in hook, composite, gap and spring. Band is not modeled in care of bare frame and masonry care. Similarly rigid diaphragm also play significant role for enhance the stiffness of the building [15]. Base shear data presented at Tables 1–4 and Figures 7–9.

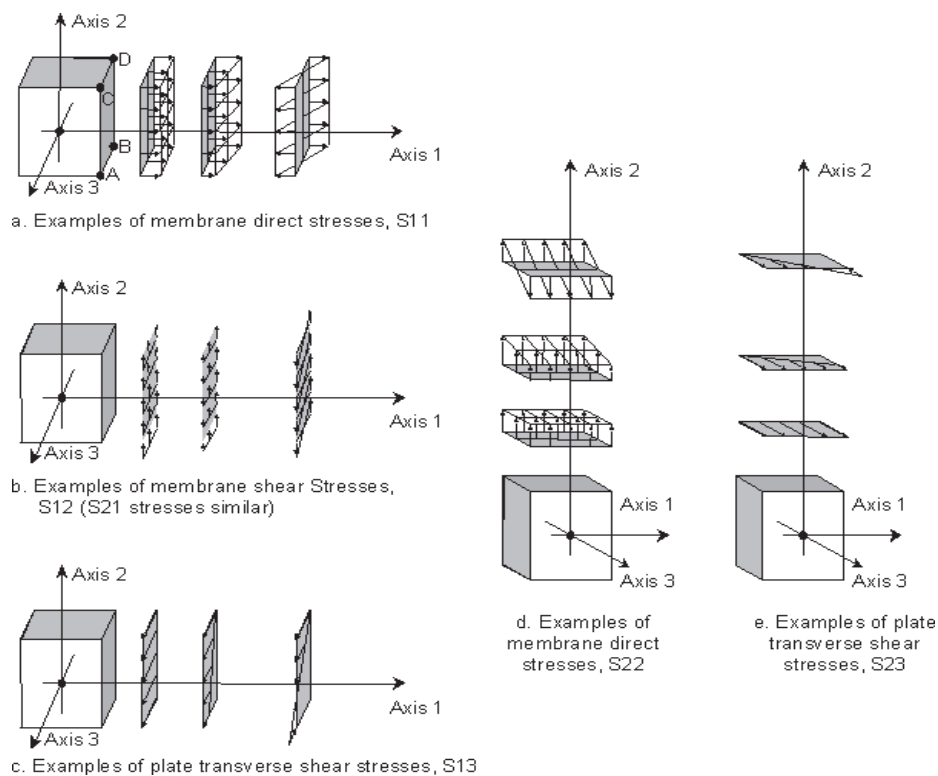
Figure 10. Stresses on thick shell elements

Output of shell element internal stresses. The basic shell element stresses are identified as S11, S22, S12, S13, and S23. You might expect that there would also be an S21, but S21 is always equal to S12, so it is not actually necessary to report S21. S_{ij} stresses (where i can be equal to 1 or 2 and j can be equal to 1, 2 or 3) are stresses that occur on face i of an element in direction j . Direction j refers to the local axis direction of the shell element. Thus S11 stresses occur on face 1 of the element (perpendicular to the local 1 axis) and are acting in the direction parallel to the local 1 axis (that is, the stresses act normal to face 1). As another example, S12 stresses occur on face 1 of the element (perpendicular to the local 1 axis) and are acting in the direction parallel to the local 2 axis (that is, the stresses act parallel to face 1, like shearing stresses). The Figure 10 shows examples of each of these basic types of shell stresses. Structural analysis program reports internal stresses for shell elements at the four corner points of the appropriate face of the element [15].

Higher stress found in the connection of timbers, connector inters face and plank area this scenario show that timber members are must responsible for withstand all types of stress of house and increase the seismic performance of the buildings. Among all the model analysis the axial stress along X-axis S11 and S22 is found in masonry and bare frame model and in case of gap, hook, composite, rigid and spring model have less (Tables 5–8). It be clearly seen that model with wooden band and band connector having less amount of stress, i.e. wooden member responsible for to counteract out of plane failure and in plane failure.
